December 2000

Volume 17, No. 3

SNOWBLOWER FAILURE ANALYSIS CASE STUDY

By Dennis B. Brickman*

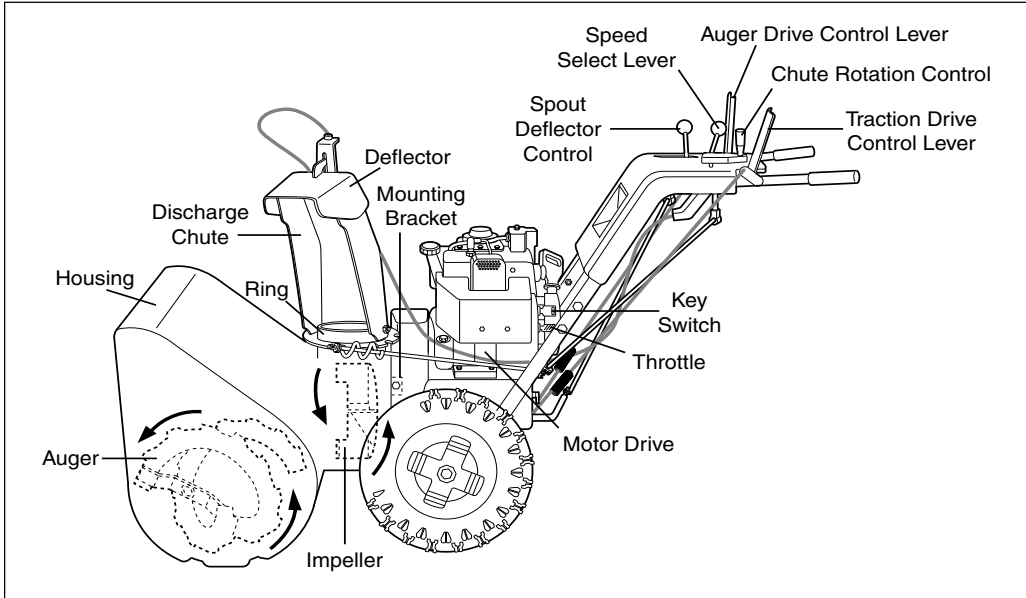
Figure 1 - Snowblower

The subject professional 10 horsepower two-stage snowblower depicted in Fig. 1 utilizes an auger to collect the snow and an impeller to blow the snow out of the discharge chute. The auger is belt driven by the crankshaft pulley (A) off the engine crankshaft as shown in Fig. 2. The auger is engaged by moving the auger engagement lever (D) to the handle, which tensions cable (H) into spring (I). Upward force on the tension spring rotates cross shaft assembly (J) which moves idler pulley (C) into contact with the auger drive belt (K). Releasing the control lever allows the cross shaft (J) to rotate, moving the idler pulley out of contact with the drive belt. Adjuster (G) sets the auger drive belt tension. The adjustment is made by changing the position of a nut on the lower threaded end of the cable positioned inside the tension spring (I).

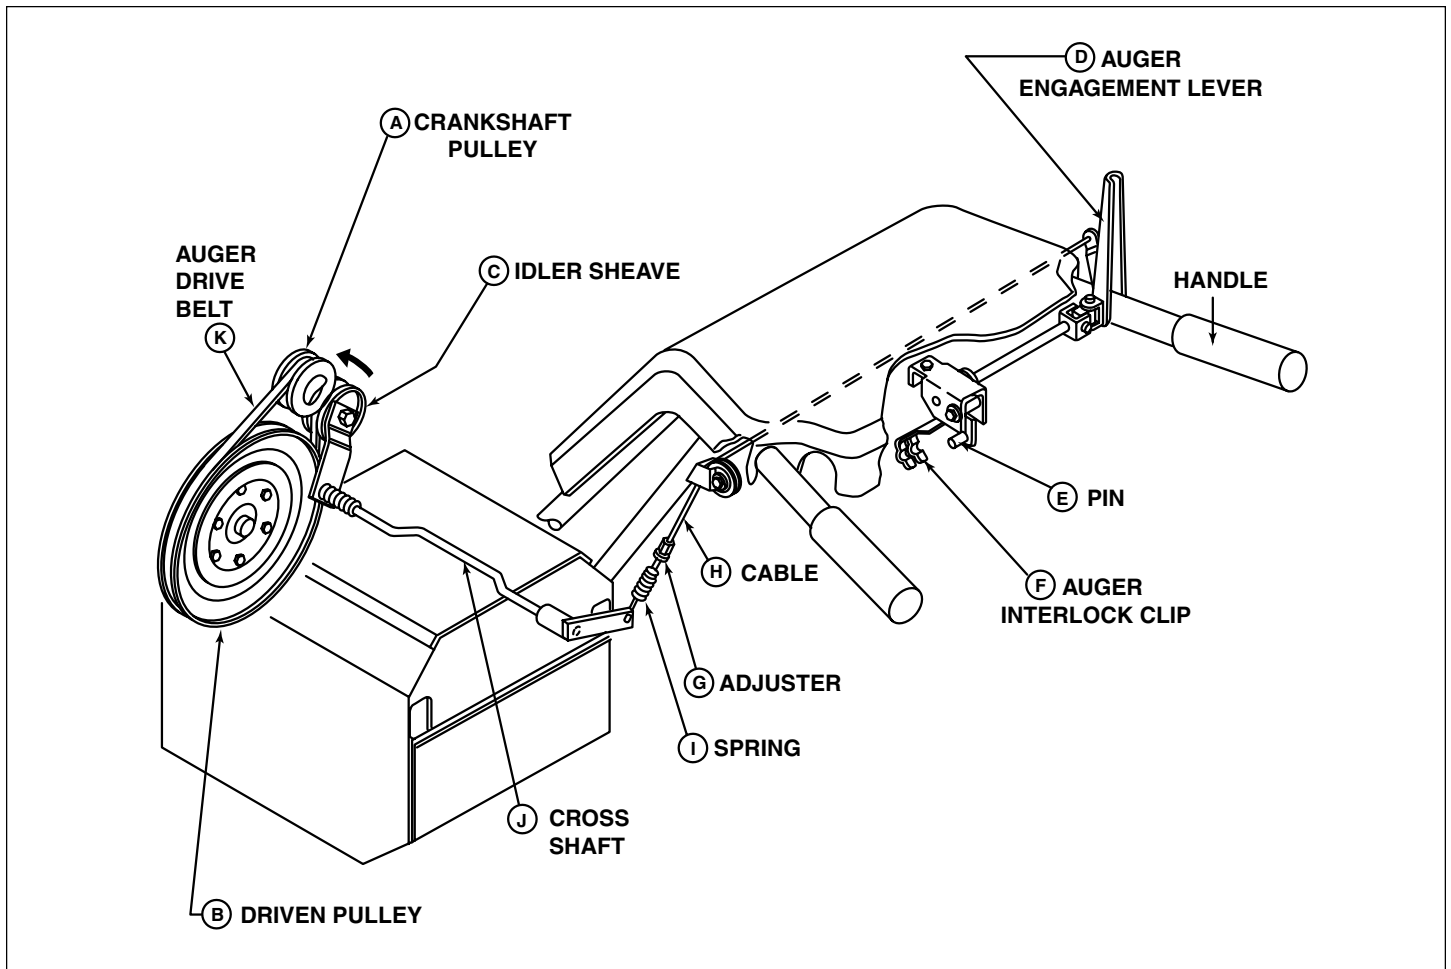
Figure 2 - Auger Control System

The auger drive and traction drive have an interlock system which allows the machine to be operated from either handle, while keeping both functions engaged. Whenever the auger engagement lever is held down, pin (E) engages in clip (F). The clip holds both auger and drive controls, but releases when hands are removed from the controls.

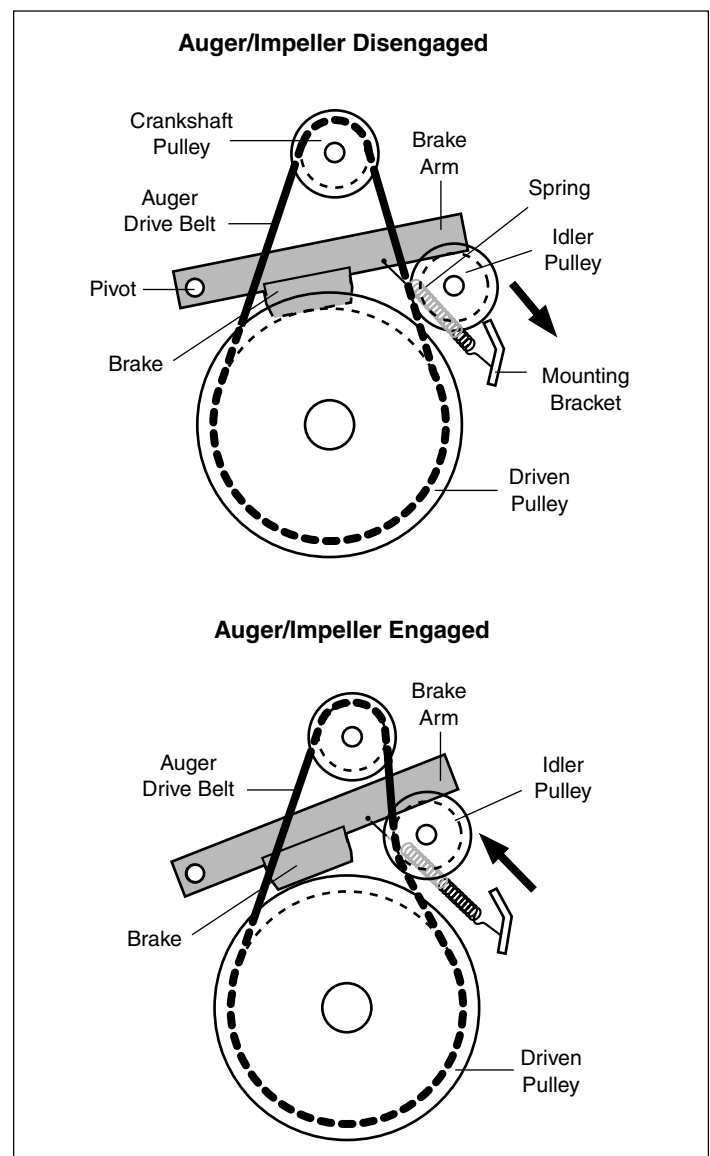
Figure 3 - Snowblower Auger/Impeller System

leaves the operator position." According to the appendix of ANSI B71.3-1984, a five second stopping time is generally below the normal time it takes an operator to leave the operator's position and to reach the hazard area of the rotating impeller. Figure 3 illustrates the auger/impeller system for the subject snowblower. When the auger engagement lever is moved to the handle, the idler pulley moves into contact with the auger drive belt and the brake arm pivots, releasing the brake from the driven pulley. This allows the auger and impeller to rotate under power. Releasing the auger engagement lever moves the idler pulley out of contact with the drive belt and the brake makes contact with the driven pulley. This causes the auger and impeller to come to rest in less than two seconds when the snowblower is properly adjusted. At the time of the accident, the auger and impeller continued to rotate for at least 10 - 13 seconds after the operator released the operator presence controls for the auger/impeller drive and the traction drive. Although the operator's manual and the technical manual for the snowblower provide instructions for adjusting the auger/impeller system, no instructions are given for the required stopping time of the auger/impeller.

Potential causes for extended auger/impeller stopping time include the following:

1. Broken/disconnected spring.
2. Broken mounting bracket.
3. Improper auger drive cable adjustment.
4. Improper auger drive belt adjustment.
5. Tight auger drive belt.
6. Brake arm/mounting tab interference.
7. Broken/missing/worn brake pad.

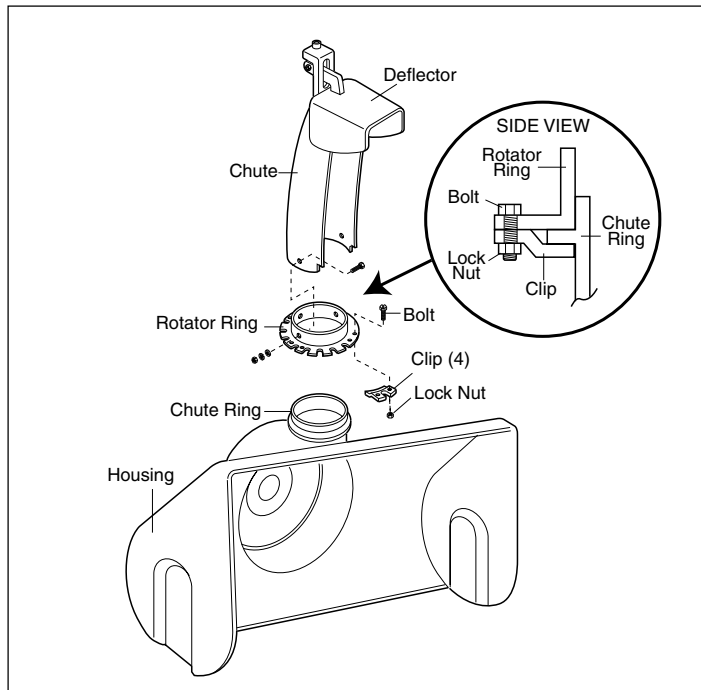
Figure 4- Auger Housing Design

1. Auger flighting bends from contact with rocks or other debris.
2. Housing sides bend from contact with curbing or other solid objects. This also puts a high stress load on welded seams at the lower corners.
3. Chute ring welds fail and destroy ring. Chute ring is not a service part.
4. Water does not drain from housing and freezes.
5. Cannot reach impeller bushing hardware without removing impeller.

Figure 4 illustrates the auger housing design for the subject snowblower. Examining Fig. 4, a set of four clips are utilized to attach the discharge chute assembly to the chute ring. Figure 5 demonstrates the auger housing retrofit design. Here, bolts are utilized with a retainer, bushing, and ring gear to secure the discharge chute to the auger housing.

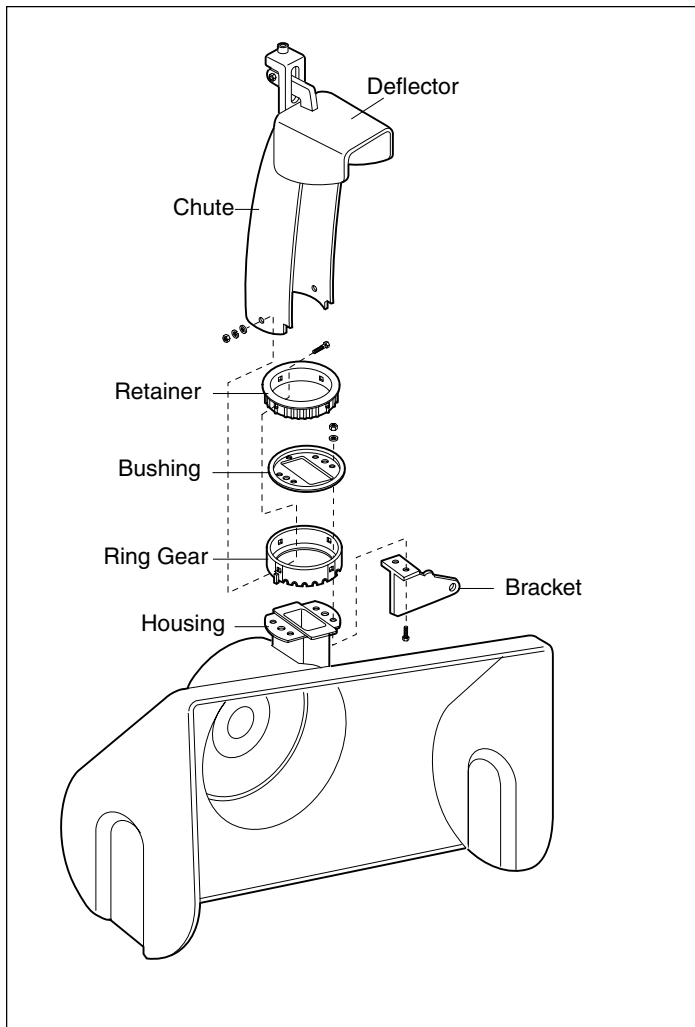
Figure 5- Auger Housing Retrofit Design

The auger housing retrofit kit became available for the subject snowblower before the accident, but no attempt was made to notify the machine owner. Machine owners were made aware of the auger housing retrofit kit after they complained about the problems experienced with their snowblowers. The new auger housing was incorporated as standard equipment into the subsequent model year snowblower design.

1. Auger thickness increased from 12 gauge (0.264 cm/0.104 in.) to 10 gauge (0.330 cm/0.130 in.) to strengthen flighting.
2. Side plates are embossed to strengthen the leading edge. Also the bottom edges have a tab added that bends around and connects to outside bolts of the scrapper bar to increase strength to each lower housing seam.
3. Housing-to-frame mounting tabs are changed to increase the weld area to secure tabs better.
4. Chute ring welds increased from 4 to 8. Also chute ring is now a service part.
5. A 0.794 cm (0.312 in.) drain hole in bottom of housing allows water to drain out to help prevent freezing.
6. Drive bolts with a serrated shoulder are used to hold the impeller bushing in place. This will reduce labor time if bushing has to be replaced.

1. Notify the subject snowblower owner of the availability of the auger housing retrofit kit and install the retrofit kit on the machine.
2. The repair shop can start, operate, and test the snowblower after the auger/impeller housing is reassembled to the motor drive before the accident to ensure that the auger/impeller stopping time is five seconds or less when the operator releases the operator presence controls for the auger/impeller drive and traction drive.
