# AFETY BULLET

## Know As Arcs—In-Line & Wet-Wire **Electrical Fires**

by John A. Campbell, P.E.<sup>†</sup>, Scott M. Howell, P.E.<sup>††</sup>

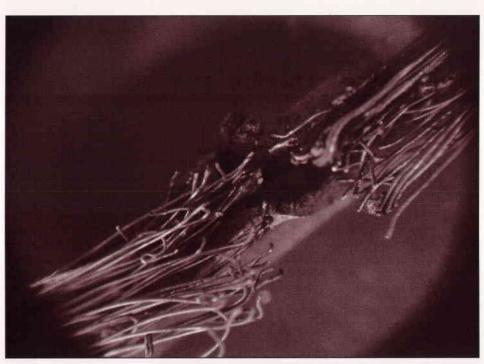
Copper Cord After In-Line Arcing

The cord, pictured on Page 1, was a two conductor, 18 gauge, copper stranded wire cord with HTN insulation on a 1200 watt electric iron. The failure occurred at the point the cord entered a flexible strain reliever attached to the body of the iron. The only visible exterior damage was a small hole in the insulation on one of the conductors and a lack of visible copper wire when looking into the cord from the hole. The entire stranded copper conductor had melted away for about one quarter inch leaving what appeared as tunnels in the insulation in both directions from the point of insulation failure. The insulation around the second conductor and between the two conductors was undamaged.

Removal of the insulation around the severed conductor revealed molten globules of copper had flowed into the strands and were intermingled with the strands away from the point of failure. Most of the ends of the strands exhibited clean breaks although some had tapered or beaded ends. Removal of the electrical insulation around the second and parallel conductor revealed the electrical wires were all intact. There were no broken strands nor other damage to the second conductor.

This incident demonstrates that in-line arcing can occur and start a fire. Also, the flow of current through the wire is limited by the connected load; in this case a 1200 watt iron which would pass 10 amps at 120 volts. The current flow can never get so large as to trip a circuit breaker as long as the connected load does not overload the circuit.

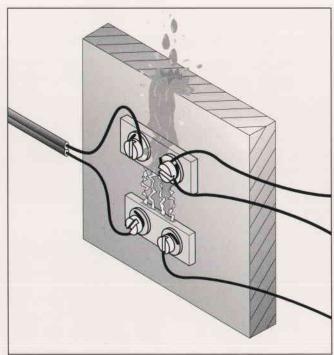
Arc-tracking is normally associated with high voltage circuits rather than the common voltages encountered in residential and small commercial buildings. The wet-wire arc-tracking phenomenon occurs when a conductive liquid drops onto an insulating surface and the liquid bridges between two exposed electrical connections at different voltage potentials. This effectively creates a high resistance short circuit. Electrical arcing through the liquid generates heat, evaporates the liquid and slightly degrades the surface of the insulation. When the liquid evaporates, the arcing stops. A residue will be left on the insulating surface from solids that had been dissolved in the liquid. The next dropping of liquid repeats the process but the current flow will be slightly higher because the residue will be dissolved in the liquid and the insulating surface will have been degraded. This cycle is repeated until eventually the current flow is sufficient to ignite the degraded insulation. It may take hundreds of cycles before ignition occurs. The more conductive the liquid the fewer cycles required before a fire starts.

Wet-Wire Arc-Tracking
