SAFETY BULLETIN

Were His Lights On?

Minor Distortion of Vehicle Lamp Filaments in Accident Reconstruction

by Dror Kopernik, P.E.* and Michael A. Dilich**

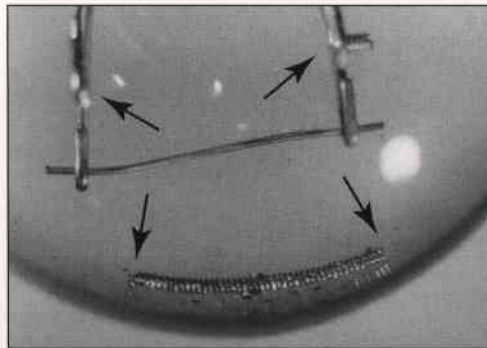
Figure 1 - Cold Shock - Thick Filament

When a lamp is off, its filament is cold and brittle and the shock of a collision can cause it to fracture (break apart) with no permanent distortion. This condition is called "Cold Shock" (Figure 1). When a lamp is on, its filament is hot and ductile and can permanently distort during a collision. This condition is called "Hot Shock." The amount of distortion varies considerably with the level of shock the lamp sustains during the collision. Major distortion (severe twisting and stretching of the filament coils) is conclusive evidence that the lamp was illuminated at the time of impact (Figure 2). Minor distortion (slightly bowed or curved filament) is not as conclusive. It may result from hot shock, or from a normal condition that existed prior to impact which was caused by a mechanism other than a hot shock.

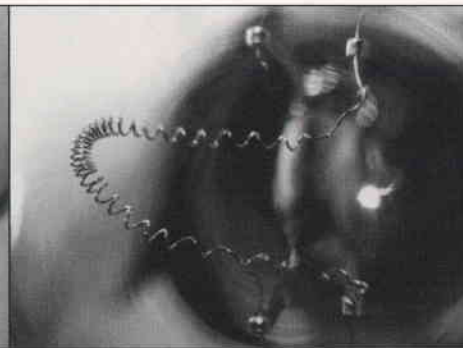
Figure 2 - Hot Shock

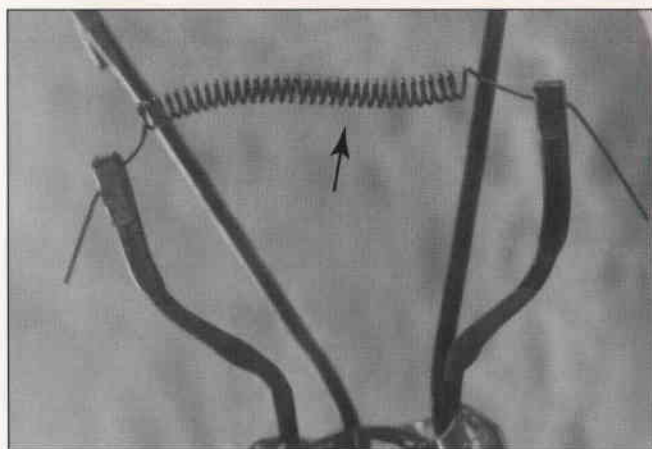
Minor distortion of lamp filaments can be introduced during manufacture of the lamp. When the filament is attached to its supporting posts, it can be distorted into a subtle "S" shape (Figure 3) or bow (Figure 4). Manufacturing related distortion will still display substantially uniform spacing of the filament coils (Figures 3 and 4).

Figure 3 – Manufacturer Induced Subtle "S" Shape
(Unused "Wagner" 1157 Bulb)

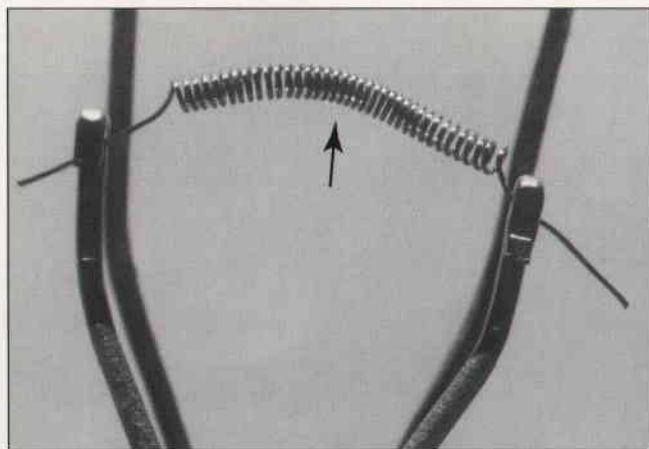
Figure 4 – Manufacturer Induced Filament Bowing
(Unused "Phillips" 1157 Bulb)

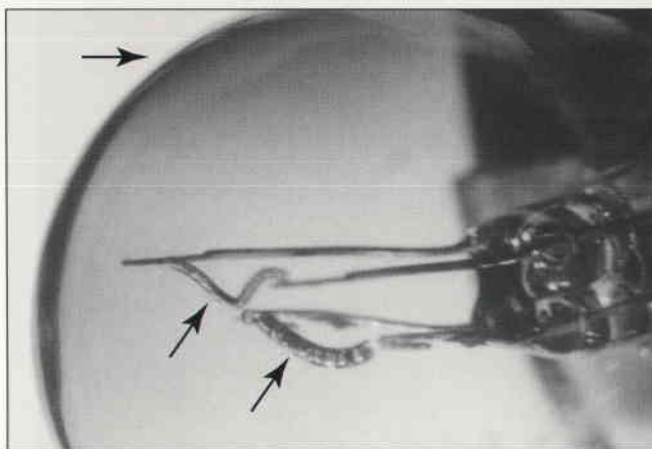
Figure 5 – Age Sag and Darkened Glass - Old Bulb

Another cause of minor filament distortion is age. This distortion is always downward and is referred to as "Age Sag" (Figure 5). In addition to the minor downward distortion of the aged filament, one may find the glass above the filament darkened (Figure 5) and the filament wire rough and pitted in appearance (Figure 6). As with the manufactured distortion, the spacing of the filament coils remains substantially uniform.

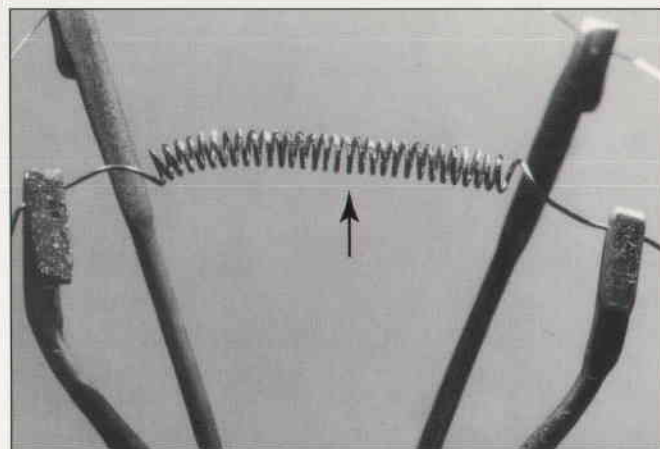
Figure 6 – Rough Pitted Surface - Old Bulb

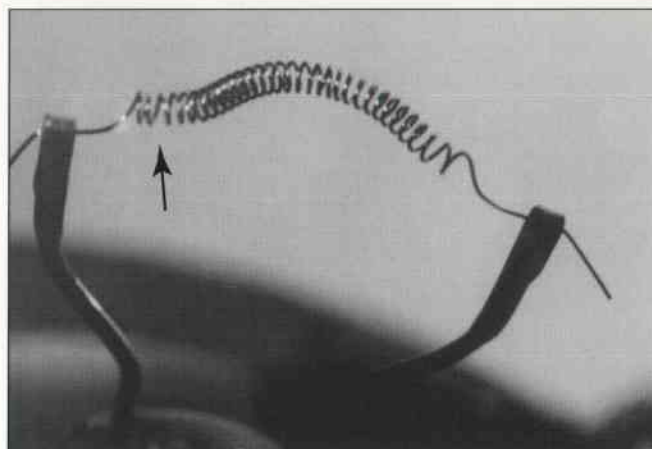
Figure 7 – Stretched Coils Near Ends of Filament
(Laboratory Test Induced Hot Shock)

manufacturing or age sag. In fact, there may be cases where all three types of distortion coexist and cannot be distinguished from one another. The presence of a few obviously stretched coils, however, generally indicates that the filament was stretched from hot shock and that the lamp was illuminated at the time of impact. For example, the stretching of coils at the ends of the filaments shown in Figures 7 and 8 was caused by mild hot shock in laboratory tests. The degree of coil stretching at the ends of these filaments is not normally caused by manufacturing or age sag.

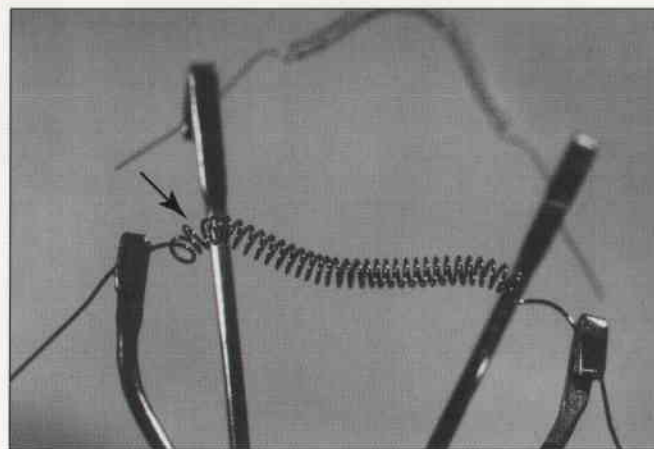
Figure 8 – Stretched Coils Near Ends of Filament
(Laboratory Test Induced Hot Shock)
