# SAFETY BRIEF

Volume 15, No. 2

## Commercial Walk-Behind Lawn Mower Failure Analysis Case Study

By Dennis B. Brickman\*

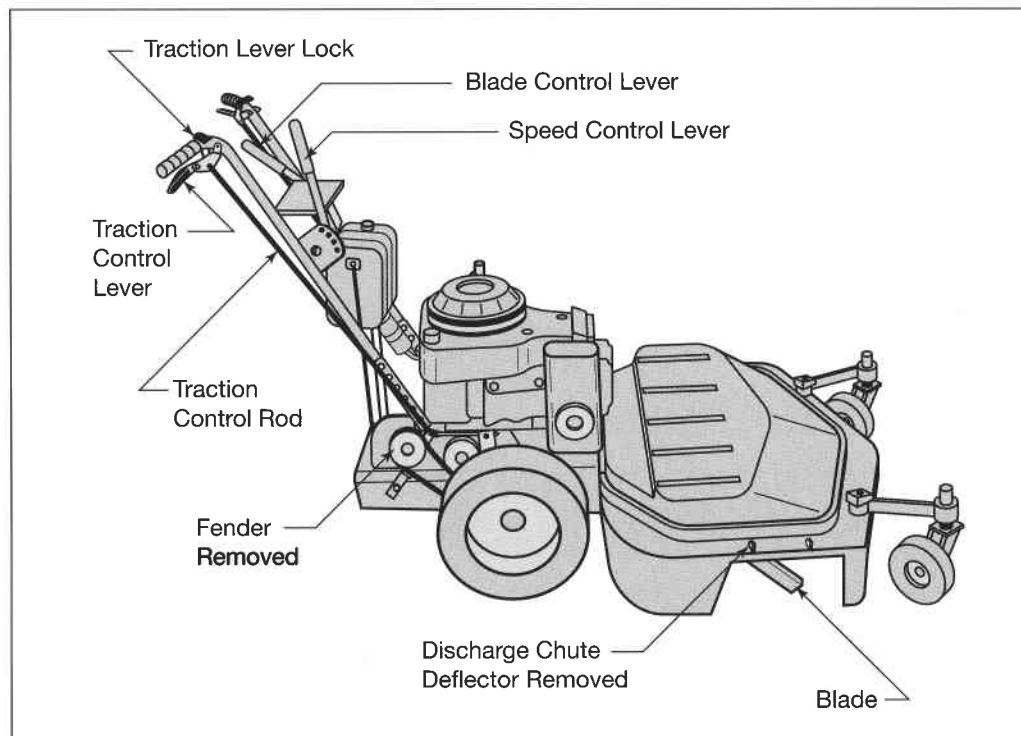
The subject mid-size commercial walk-behind lawn mower depicted in Fig. 1 utilizes a pair of three position traction control levers at the operator's console as shown in Fig. 2. When both traction control levers are released into the traction engage position, the mower has straight forward propulsion without requiring the operator to maintain contact with the levers. When both traction control levers are fully squeezed, the wheel drive clutch is disengaged and a friction brake

Figure 1 - Commercial Walk-Behind Lawn Mower

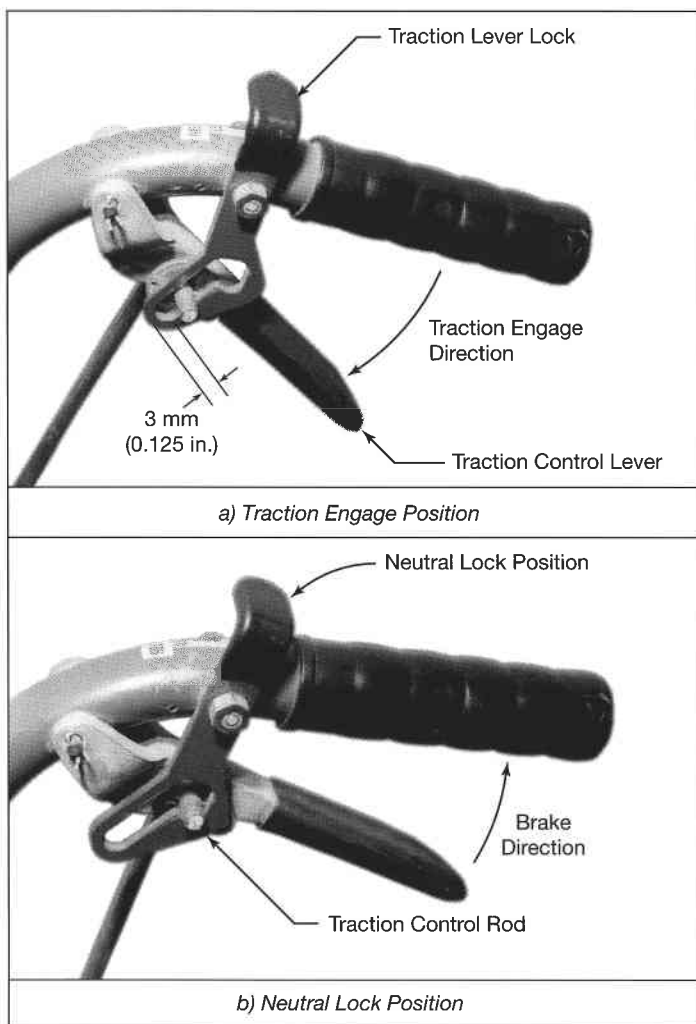
Figure 2 – Right Traction Control

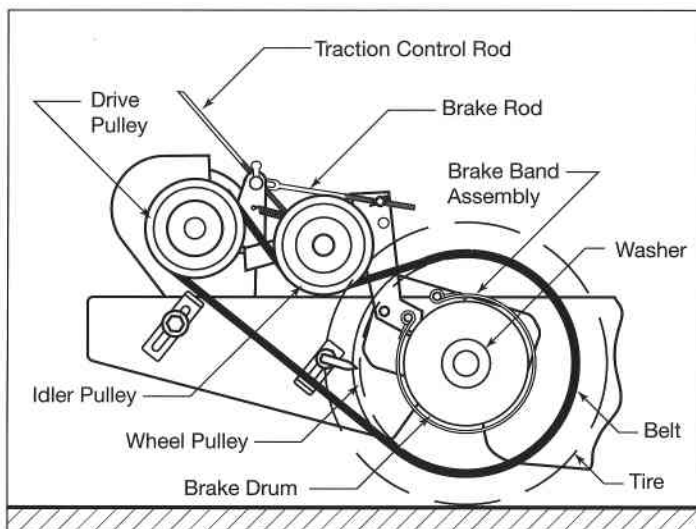
Figure 3 – Right Wheel Drive Clutch/Brake Assembly in Brake Position (Fender Removed)

is applied which stops the forward propulsion of the mower as illustrated in Fig. 3. When the traction control levers are placed into the intermediate neutral position by applying the traction lever locks, the mower's wheel drive is disengaged, but no additional braking is applied to the wheels. The mower utilizes a skid-steer concept for steering. In order to make a right turn, the right traction control lever is squeezed into the intermediate neutral or fully

4. There was considerable circular scoring present on the right brake band anchor plate at the radius of the brake drum.
5. There was a 3.18 mm (0.125 in.) indentation of the wheel pulley rim. In addition, a gouge mark was observed on the pulley caused by interference between the pulley indentation and the brake band pivot anchor.

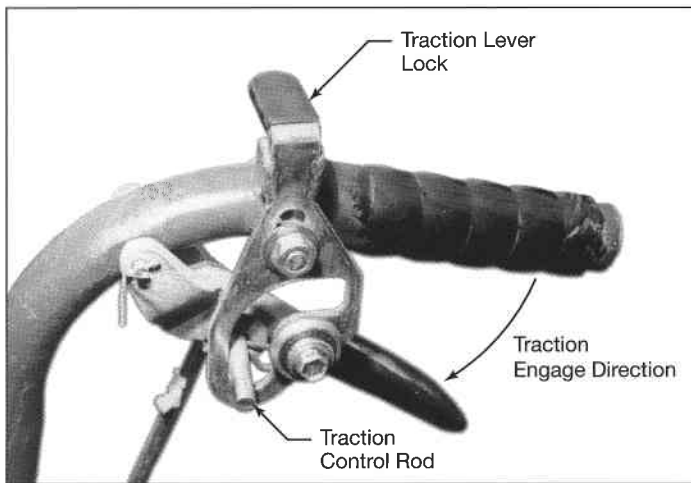
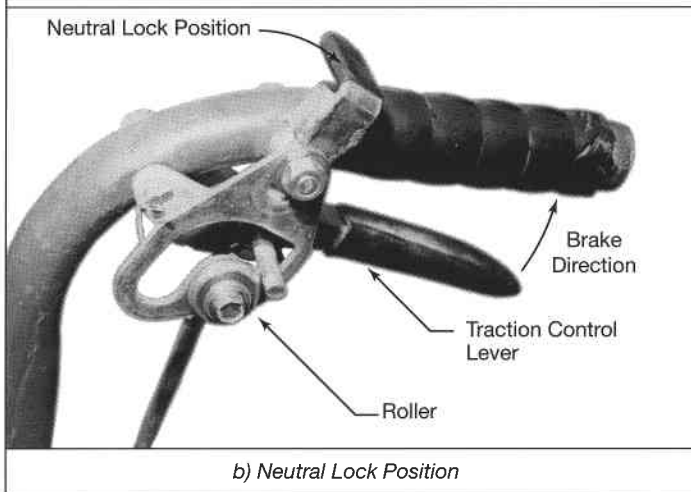
a) Traction Engage Position

b) Neutral Lock Position

Figure 4 – Right Traction Control Position with Roller Lock

It was alleged by the injured operator that his accident would not have occurred had the new style roller locks shown in Fig. 4 been equipped on the subject mower.

4. With an improperly adjusted right drive wheel clutch and brake assembly, the mower equipped with the roller locks can still make a sharp right turn after the right traction control lever is released from a slightly squeezed position as described by the mower operator at the time of his accident.

1. Installed new style roller locks.
2. Adjusted brakes and clutches.

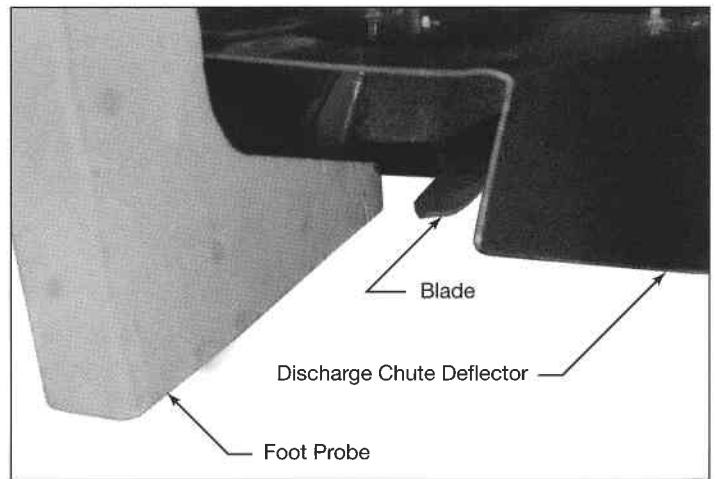
Figure 5 – ANSI B71.4-1984 Foot Probe Test

**ANSI B71.4-1984 Foot Probe Testing.** In accordance with the test protocol outlined in paragraph 8.3.2 of ANSI B71.4-1984 (1), the prescribed wooden foot probe was inserted into the discharge opening of an exemplar mower equipped with the original discharge chute deflector as shown in Fig. 5. The mower complied with the ANSI B71.4-1984 foot probe test acceptance requirement by not allowing the probe to enter the path of the blade. The foot probe test was repeated with the discharge chute deflector removed and the probe made contact with the blade. Finally, the probe was inserted under the front of the exemplar mower deck and the probe did not make blade contact. These tests were repeated using a live human foot wearing a sneaker and similar results were obtained.

1. The subject injury to the mower operator's foot would have been prevented had the discharge chute deflector been in place at the time of the accident.
