SAFETY BRIEF

May, 2002

Boiler Feedwater Pipe Failure by Flow-assisted Chelant Corrosion¹

Boiler feedwater pipe failure by flow-assisted chelant corrosion

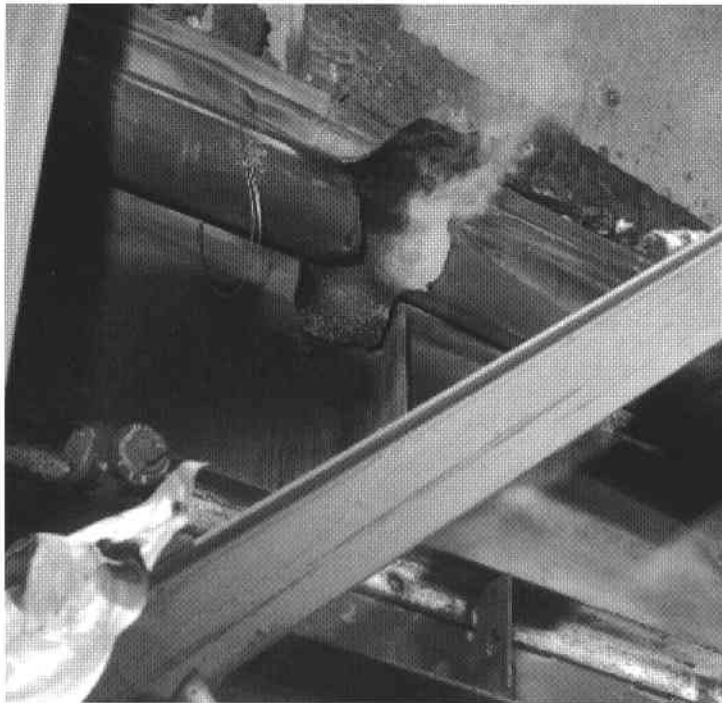
Six-inch boiler feedwater pipe rupture

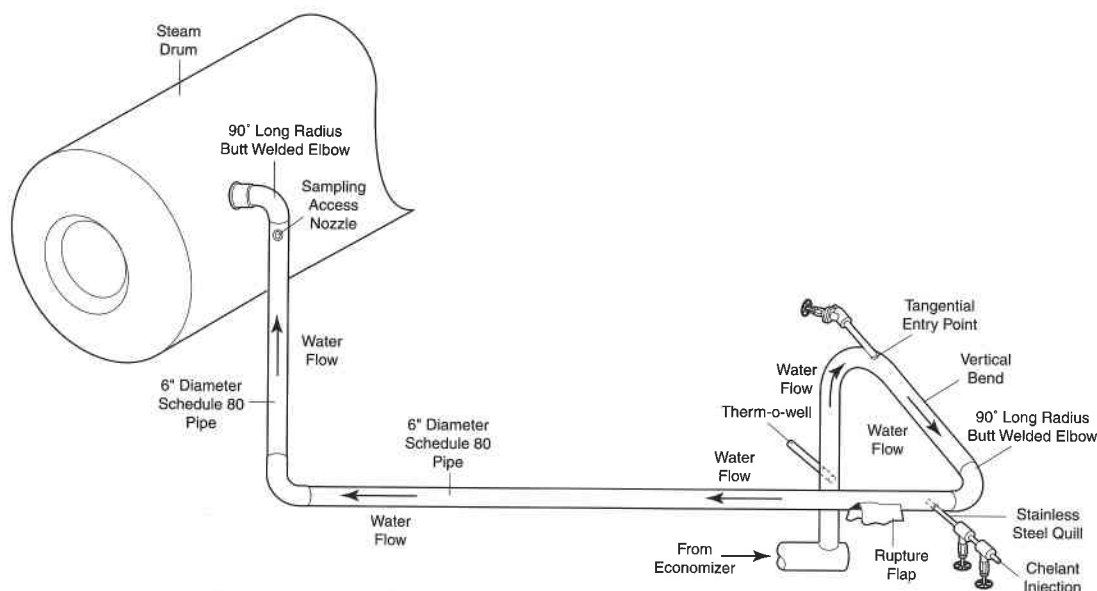
Fig. 1. Schematic of feedwater line from economizer to steam drum.

was installed and the all-welded Schedule 80, 6-inch feedwater line from the economizer to the steam drum was re-routed and replaced to accommodate the change. In about 1977 an injection quill was installed in this section of pipe for chemical dosing of the feedwater. The basic geometry of the pipework from the outlet of the economizer to the steam drum is shown diagrammatically in Fig. 1. The feedwater flows out of the economizer directly into a pipe tee which turns the flow vertically upwards through a long-radius bend. Inserted into this curving pipe, at right-angles to the flow, was a thermocouple well tube fitting, used for temperature measurement. The flow then passes through a horizontal 90° long-radius butt-welded elbow, and into a 15 ft straight section of pipe. The quill was installed in a horizontal plane into the flow at the upstream end of this section of the feedwater line, purposely to avoid any potential corrosion problems at the long-radius butt-welded elbow downstream. The final section of the feedwater line is an 8.5 ft vertical riser, ending with a further long-radius elbow connected to the steam drum. Within the steam drum is a distributor pipe to ensure even flow and good mixing of the feedwater as it enters the steam drum.

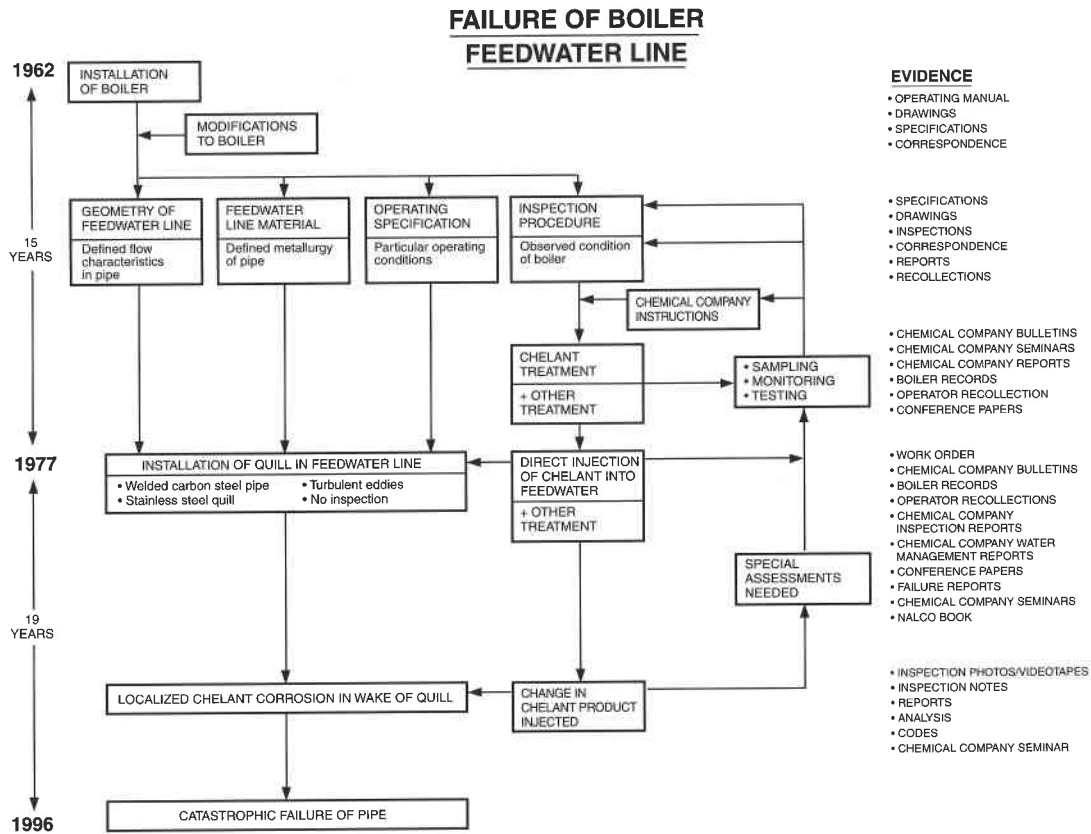
Fig. 2. Summary of boiler history prior to feedwater line rupture.

The boiler is reported to have been operating normally at the time of the failure, and its original performance has been maintained by feedwater treatment according to consultant service agreements. While the boiler typically utilizes Eastern coal as a fuel source, other fuels including tires, in-plant generated RDF, and Western coal have been utilized in small percentages. The unit has generally been operated in the upper range of capacity (i.e. above 200,000 lb/h) in order to meet plant demand. The main plant steam header is maintained at 850 psig and 900°F, while feedwater is controlled to approximately 925 psig and 400–414°F as it exits the economizer. Annual inspections concentrated on boiler pressure parts within the boiler itself, between the feedwater inlet valve and steam outlet stop/check valve. Note that only recently have companies begun to perform periodic detailed inspections on feedwater piping systems external to the boiler proper, although in nuclear facilities such inspections have been included for several years. A summary of the boiler history prior to the feedwater line rupture is provided in Fig. 2.

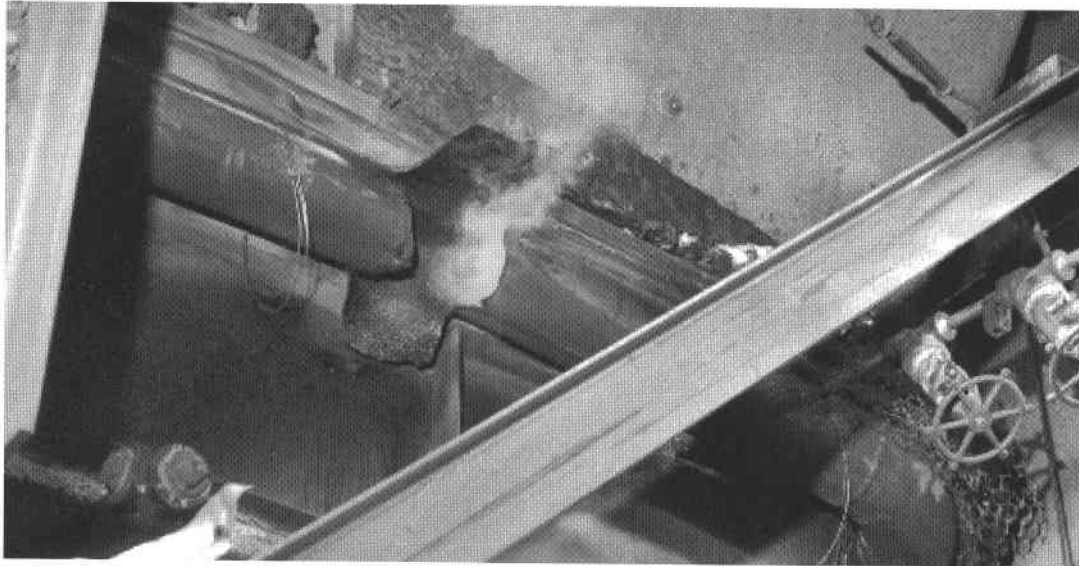
Fig. 3. Six-inch boiler feedwater pipe rupture.

Shortly after the catastrophic failure in the section of feedwater line shown in Fig. 1, it was concluded that the pipe rupture was caused by internal wastage of the pipe wall. Measurements showed that prior to

actual failure, the pipe wall thickness in the area of the rupture flaps was about 0.050 inches, which corresponds to a hoop stress in excess of the tensile strength of the SA 106 Grade B carbon steel material at the normal operating pressure.

appearance of flow-assisted corrosion, nor does cavitation produce the smooth well-formed pits with crisp edges characteristic of electrochemical (e.g. oxygen or acid) pitting. An objective measure of cavitation damage is the depth of metallurgical deformation, distortion of metal grain structure, and work hardening.

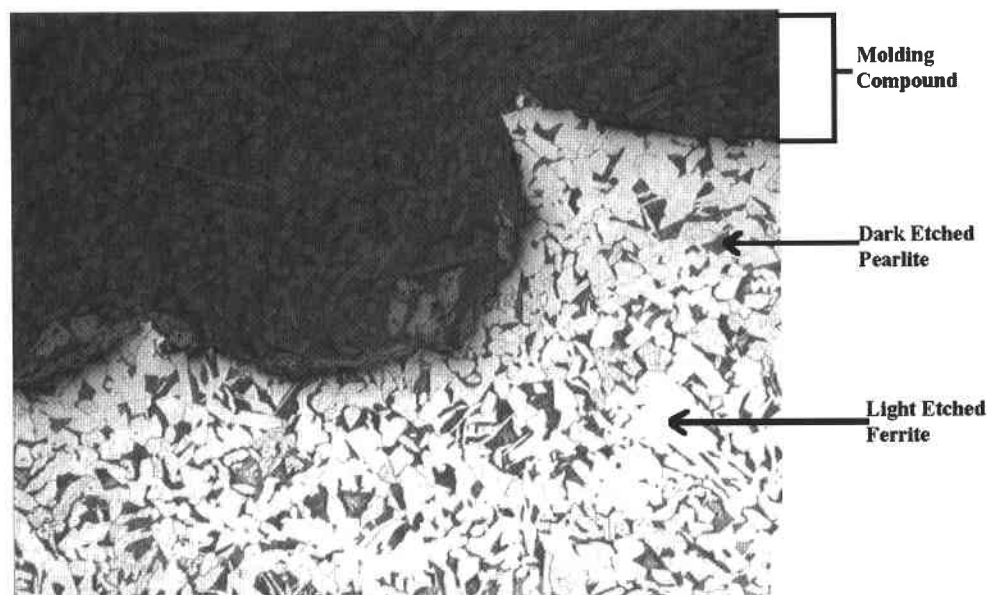
A metallurgical evaluation of the failed area exhibited in Fig. 4 did not show any signs of plastic deformation or the associated work hardening. There was no evidence of fatigue cracks, slip lines, extrusions or intrusions, nor any of the aforementioned features indicative of cavitation damage in the samples taken from the immediate location of the failed area.

Fig. 4. Photograph at 100× magnification exhibiting the microstructure of the tube sample internal surface consisting of dark etching pearlite in a matrix of white etching ferrite. Etched in 2% nital. The sample was taken from the failed area of the pipe. No evidence of plastic deformation was observed in this area.
