## THE RUNAWAY DIESEL - PART II A Side By Side Mechanical Analysis

By Christopher W. Ferrone\* and Charles Sinkovits\*\*

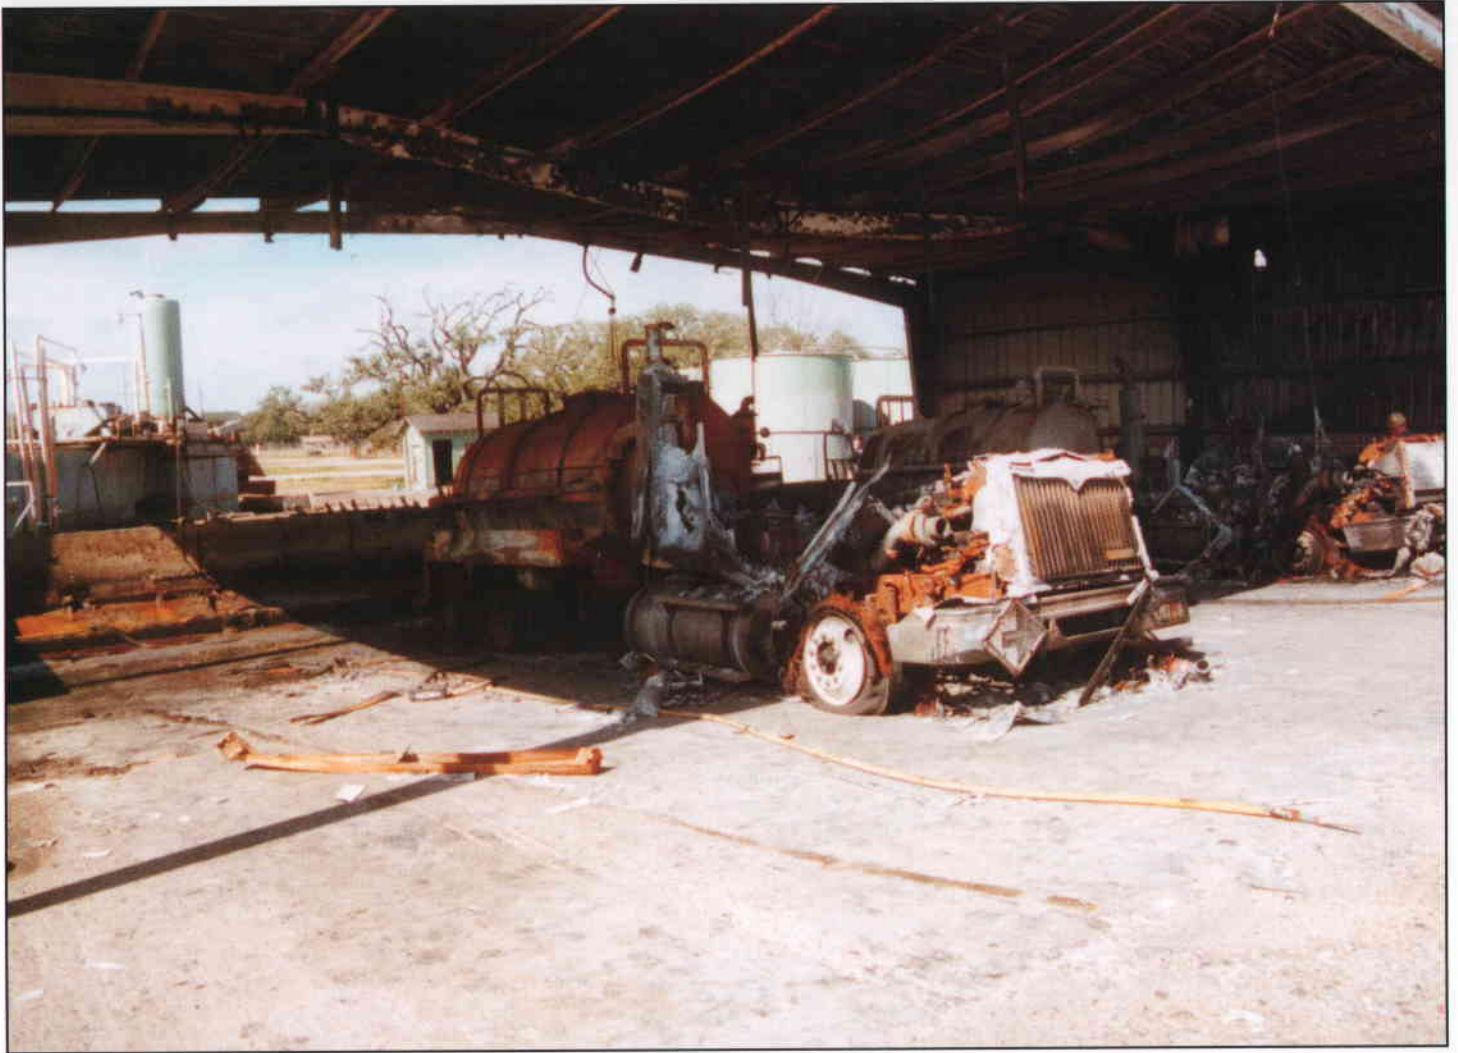
On January 13, 2003 in Rosharon, Texas, two tank trucks unloaded waste liquids into an open collection pit at the BLSR Operating Ltd. disposal facility. Unknown to either driver or to BLSR personnel, the waste material was highly volatile and a flammable vapor cloud formed in the unloading area. Vapor was drawn into the air intakes of the trucks' running diesel engines causing them to overspeed, backfire, and ignite the flammable cloud (Photo 1). Two BLSR employees standing near the trucks were killed in the fire and three others suffered serious burns. The two drivers, who were employed by T&L Environmental Services Inc., were also burned after rushing back to their trucks when they heard the engines accelerate. One of the drivers died several weeks later from his injuries (Ref. 1).

*Photo 1 - Accident Scene (Two Trucks)*

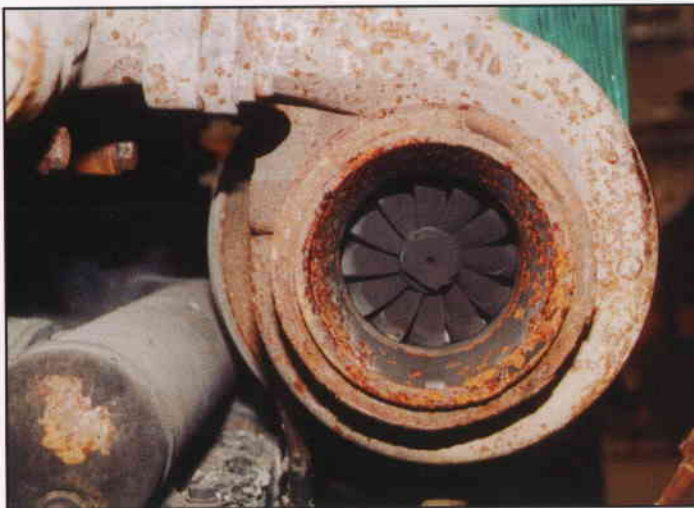
When a diesel engine burns fuel, it leaves a distinct combustion pattern. The internal components – exhaust valves, exhaust manifold and turbocharger impeller (Photo 2) – are coated with soot and piston firing surfaces are usually coated with a dark colored mixture of oil, diesel fuel and soot which ultimately leads to a black coating (Photo 3).

*Photo 2 - Turbocharger Impeller  
(North Engine) Soot Covered*

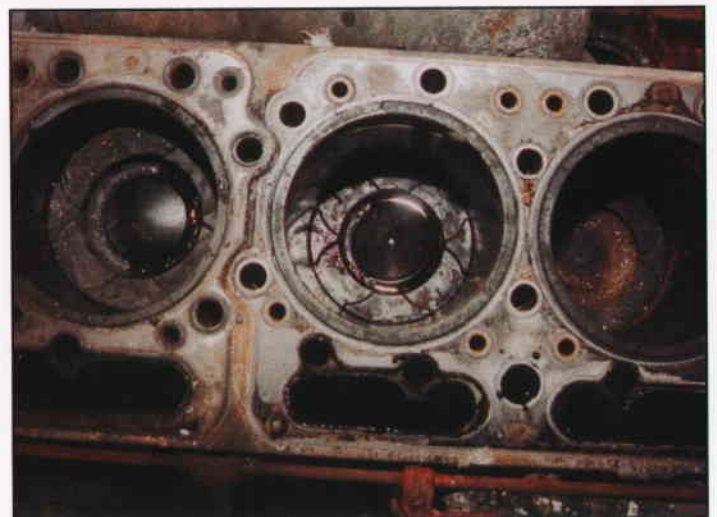
*Photo 3 - Piston Firing Surfaces (North Engine)  
Diesel Fuel/Soot Covered*

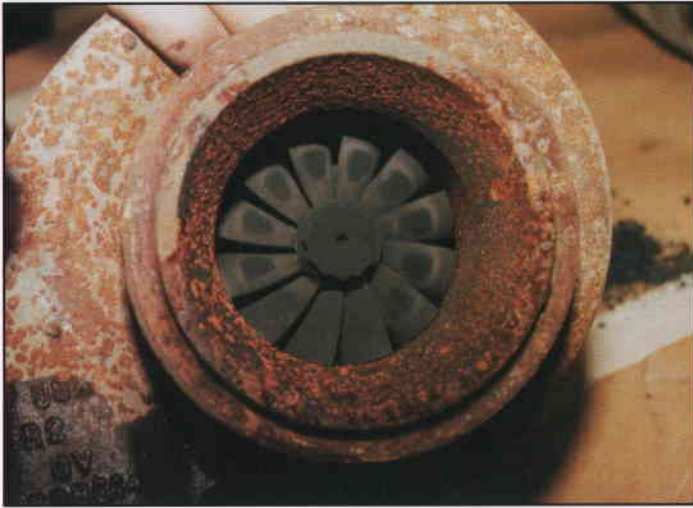
When a diesel engine ingests an *external fuel source*, the appearance of the internal components changes. The exhaust valves, exhaust manifold, turbocharger impeller and pistons become "cleaned" (Photo 4a, 4b) as a result of the subsequent "scrubbing" action and elevated temperatures which are noted by the blue appearance of the turbocharger bearings, etc. . . . (Photo 5).

*Photo 4a - Turbocharger Impeller (South Engine)  
Scrubbed Clean*

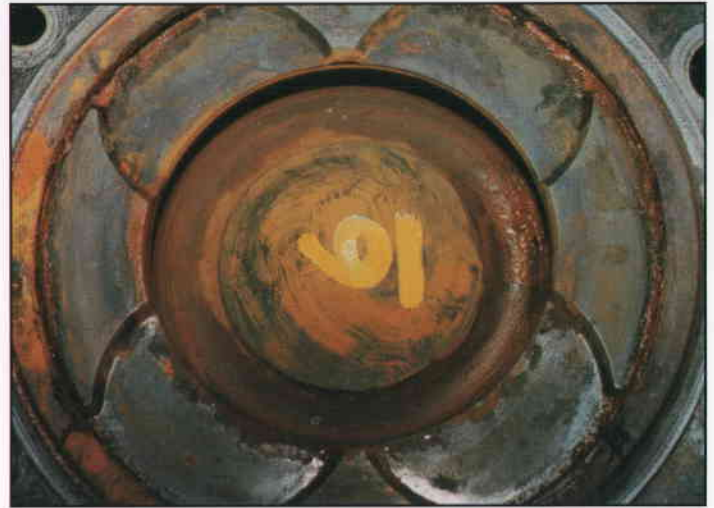
In this condition the valve train components (tappets or cam followers) lose contact with the cam lobes because the valve springs are not strong enough to overcome the momentum of the various valve train components at the overspeed RPM. The onset of valve float usually prevents higher RPM operation due to loss of compression. Extended periods of valve float will damage the valve train and subsequently put the valves in contact with piston firing surfaces (Fig. 2). This will occur at engine speeds greater than the no-load maximum. Additionally, cylinder head components, valve spring retainers and locks can become damaged (Fig. 3). Once this happens, push rods can fall down through the engine block and into the oil pan. Along the way, the push rods may become bent, showing additional evidence of overspeed. Photo 6 shows valve contact with a piston on the South engine; photo 7 shows no contact with the piston on the North engine. Photograph 8 illustrates damaged valve components for the South engine; photo 9 shows no damage on the North engine.

*Photo 6 - Piston Valve Contact (South Engine)*

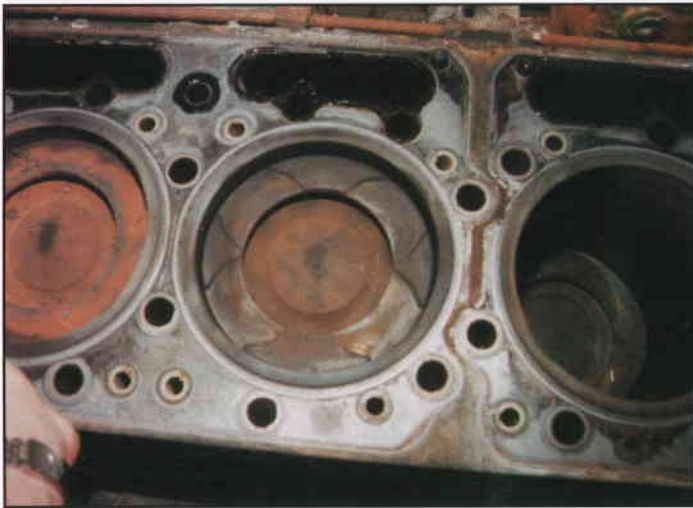
*Photo 4b - Piston Firing Surfaces (South Engine)  
Scrubbed Clean*

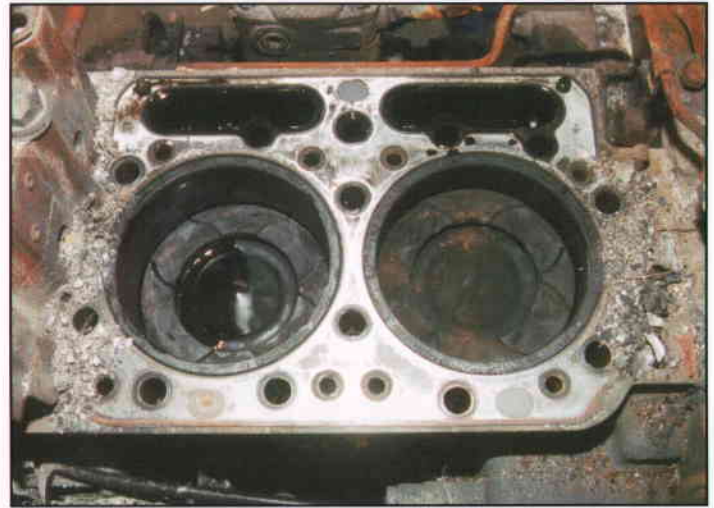
*Photo 7 - No Piston/Valve Contact (North Engine)*

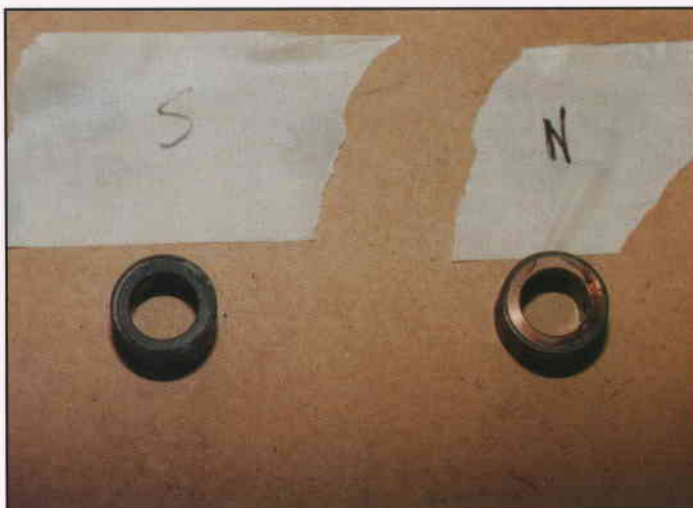
*Photo 5 - Turbocharger Bearings  
(Left) Bluing (Right) Normal*

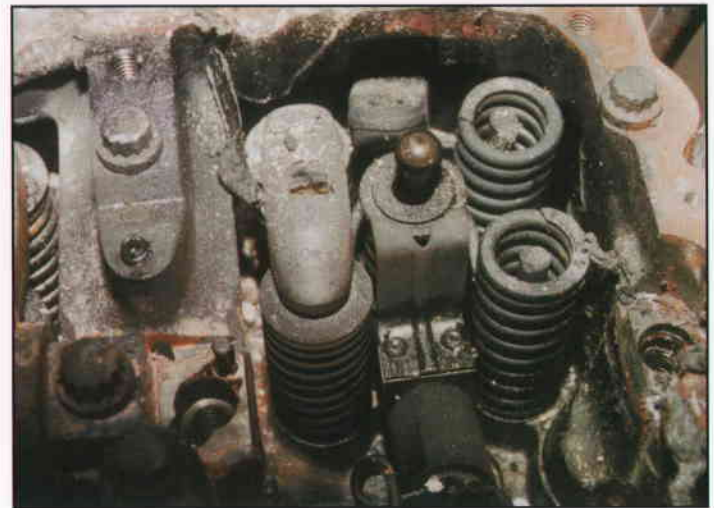
*Photo 8 - Damaged Valve Components (South Engine)*

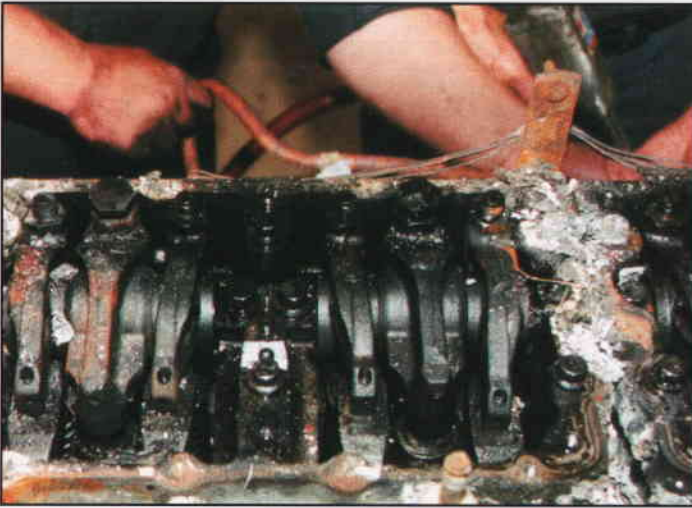
*Photo 9- Normal Valve Condition (North Engine)*

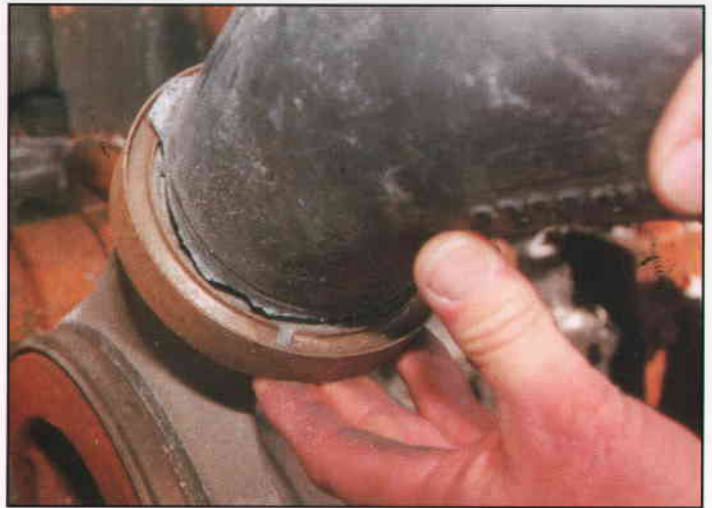
A destructive backfire is evidenced by a damaged turbocharger outlet elbow. Typically, the part is broken off of the turbocharger and "blown" clear of the main fire area (Photo 10). Damage to the 90° elbow and rubber hose (Fig. 5) is indicative of an explosion, not fire damage or heat. Photographs 11a and 11b show the South engine turbocharger with an explosion-induced broken elbow and rubber hose whereas photo 12 shows an intact, albeit melted elbow on the North engine turbocharger.

*Photo 11b - Turbocharger Outlet Elbow (South Engine) Mechanical Failure*

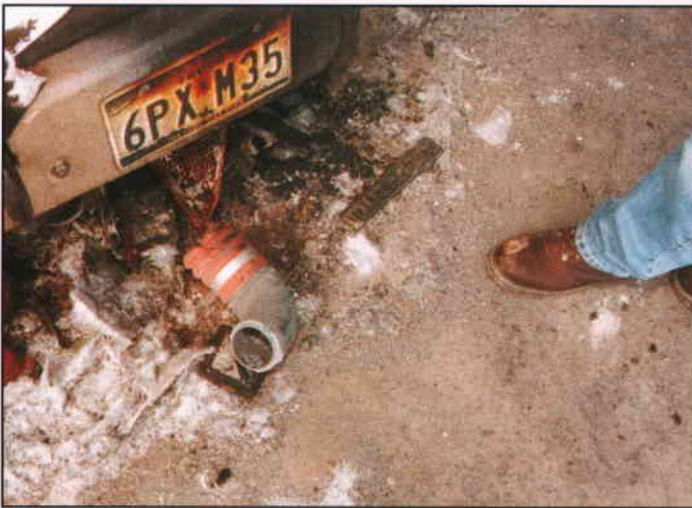
*Photo 10 - Turbocharger Outlet Elbow (South Engine)*

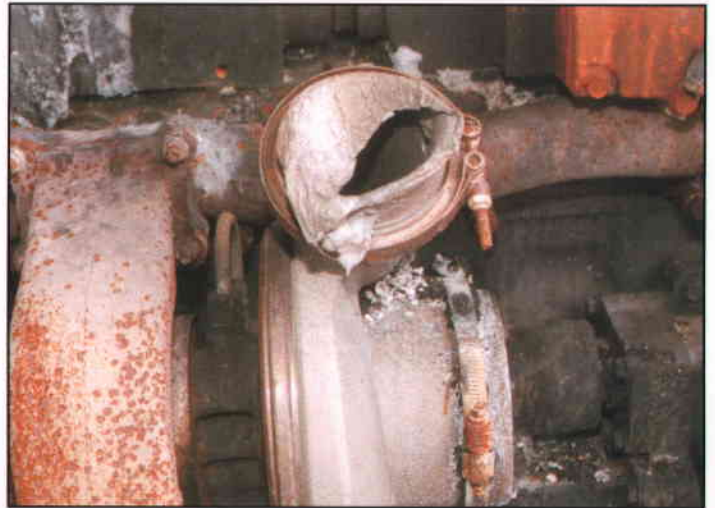
*Photo 12 - Fire Damage Turbocharger Outlet Elbow (North Engine)*

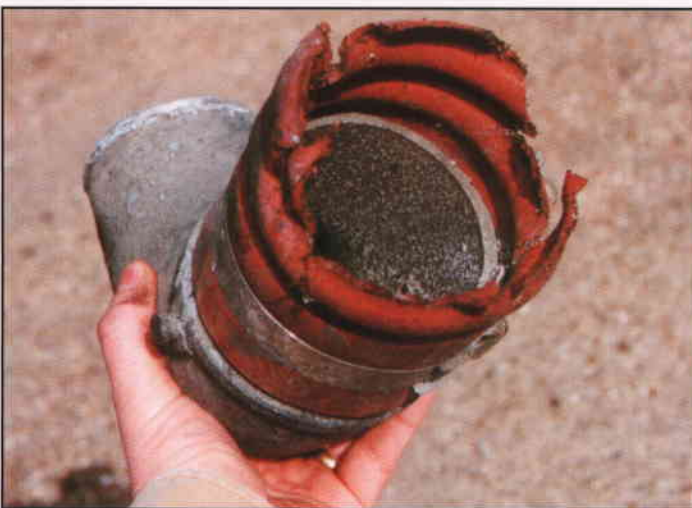
*Photo 11a - Turbocharger Outlet Rubber Hose Connection Mechanical Failure (South Engine)*

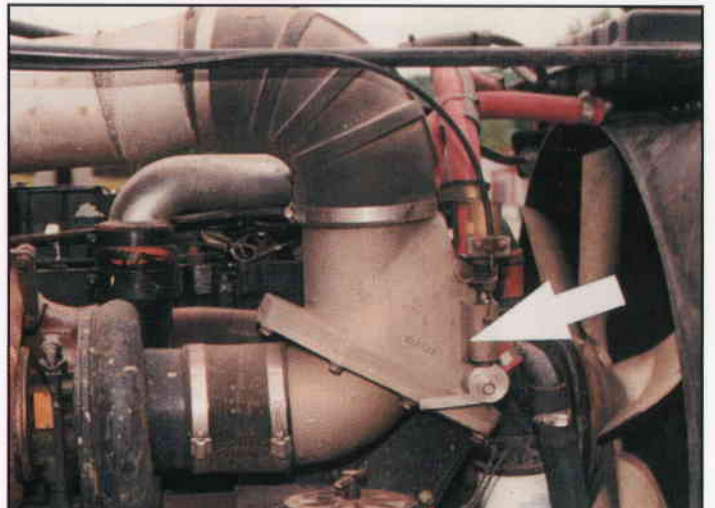
*Photo 13 - Installed Air Intake Shutoff Valve*

The first and most direct method for eliminating a runaway is to simply shut off the engine at the loading/unloading destination. If there is a need to keep the engine running, an air intake shut-off valve can be installed. These valves come in two varieties: passive and active. The passive system is automatic and sensitive to engine RPM. If the engine exceeds a preset RPM it will shut off the engine by eliminating combustion air. Active systems are usually controlled by the driver by a pull cable or a push button. When activated, a gate swings shut and positively blocks the combustion air path between the air cleaner and the turbocharger resulting in total shut down of the engine (Photo 13).
