# SAFETY BRIEF

## Safety Analysis of Roller Compactors Exposed to Rollover

by Dennis B. Brickman\* and Ralph L. Barnett\*\*

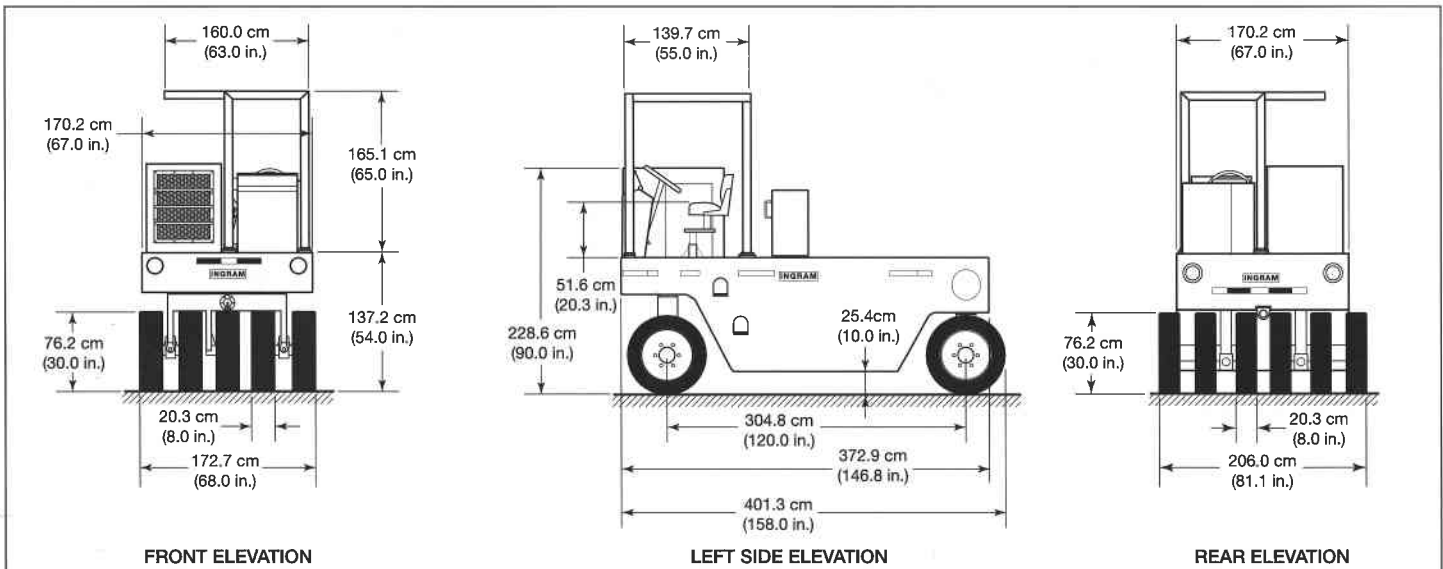
Figure 1 - Ingram Model 9-2800-PA Pneumatic Roller Compactor with ROPS

The current study focuses on the Ingram model 9-2800-PA pneumatic roller compactor which is illustrated in Figure 1. As originally configured, the machine had five front steering and four rear driving wheel sets staggered to provide continuous compaction coverage. The owner of this equipment retrofitted the rear driving wheel axle by adding an additional outboard wheel on the right and left sides. The ROPS device characterized in Figure 1 was supplied as optional equipment by Ingram.

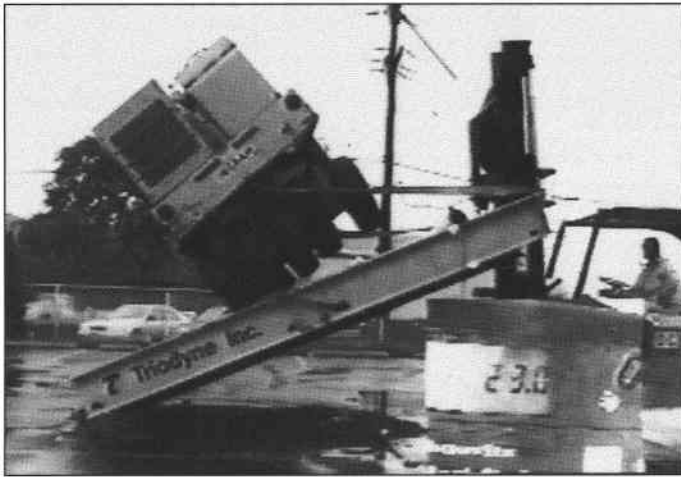
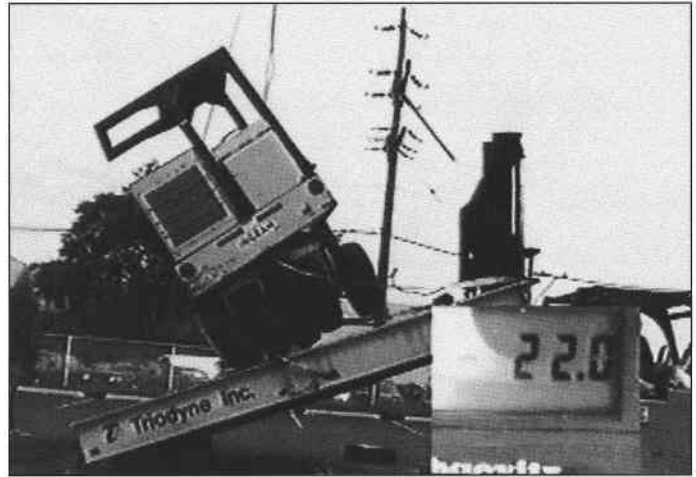
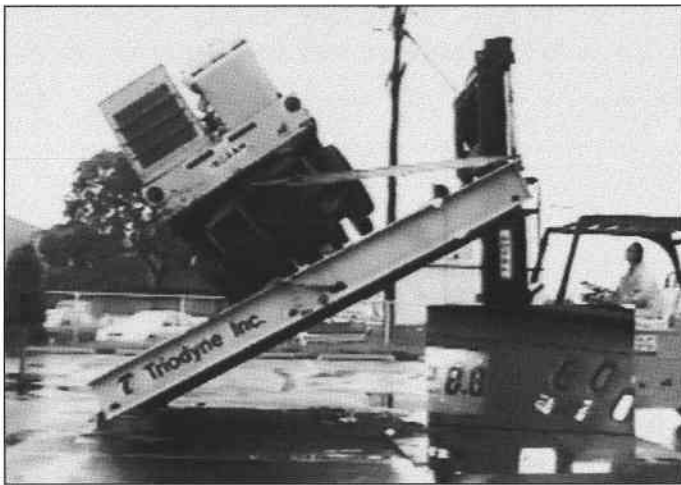
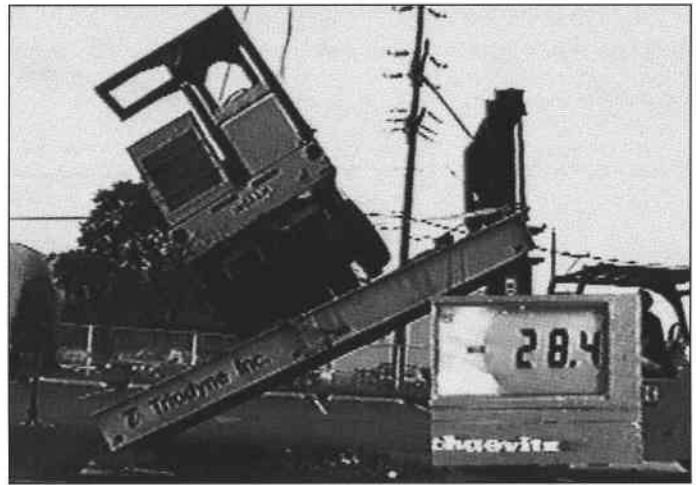
A) 4 Rear Wheels: 23.0°

B) 4 Rear Wheels: 22.0°

C) 6 Rear Wheels: 28.8°

D) 6 Rear Wheels: 28.4°

Figure 2 - Side Rollover Tests

Using ballast to bring the total weight of the Ingram pneumatic roller compactor to 9,979 kg (22,000 lb), four combinations of side rollover tests were conducted as illustrated in Figure 2. The ROPS structure studied weighed 363 kg (800 lb) and clearly raised the center of gravity of the system; nevertheless, its influence on stability is found to be negligible ( $1.0^\circ$  for four rear wheels and  $0.4^\circ$  for six rear wheels). The addition of the outboard rear tires adds approximately  $6^\circ$  of lateral tilt resistance. These results have been accumulated in Table 1 which provides the lateral stability criteria for five different machines. We observe that the Ingram roller compactor equipped with six rear wheels exceeds the lateral stability criteria given for each of the other entries.

Machine	Measurement or Criteria	Reference
Ingram Roller Compactor with 6 rear wheels and no ROPS	28.8°	Fig. 2C
Ingram Roller Compactor with 6 rear wheels and ROPS	28.4°	Fig. 2D
Ingram Roller Compactor with 4 rear wheels and no ROPS	23.0°	Fig. 2A
Ingram Roller Compactor with 4 rear wheels and ROPS	22.0°	Fig. 2B
Counterbalanced Lift Truck (Travelling with no load)	$\tan^{-1}[15 + 2.25(\text{velocity in mph})]$ maximum 26.6°	ASME B56.1-1993 (1)
Rough Terrain Forklift Truck (Vertical Mast travelling with no load)	21.8°	ASME B56.6-1992 (2)
Ride-on Mower	20°	ANSI/OPEI B71.1-1996 (3)
Ride-on Turf Tractor	20°	ANSI/OPEI B71.4-1990 (4)
Ride-on Snow Thrower	20°	ANSI/OPEI B71.3-1995 (5)

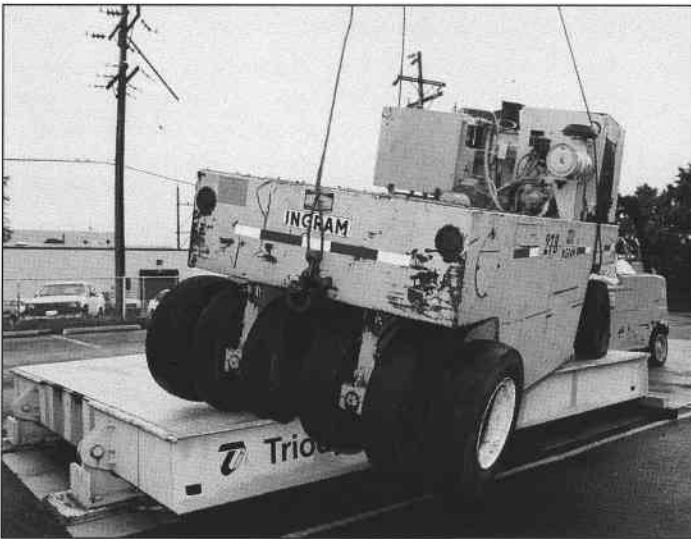
Figure 3 - Three Rear Wheels Suspended in Air

A second inquiry into the forgiving nature of the pneumatic roller compactor involves an illustration of the nature of stability using wide wheels that are either continuous or segmented. If an automobile approaches an embankment, eventually one of its wheels becomes unsupported which usually allows the entire vehicle to tilt over the embankment. Figure 3 shows the Ingram pneumatic roller compactor with three rear wheels suspended in the air while maintaining the equilibrium of the compactor. A companion illustration is given in Figure 4 which indicates that equilibrium is maintained by the roller compactor with one front wheel and two rear wheels suspended in the air.

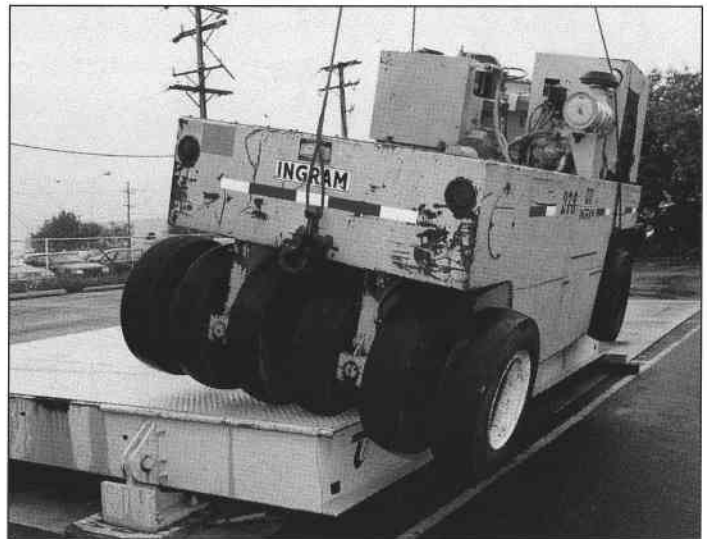
Figure 4 - One Front Wheel and Two Rear Wheels Suspended in Air

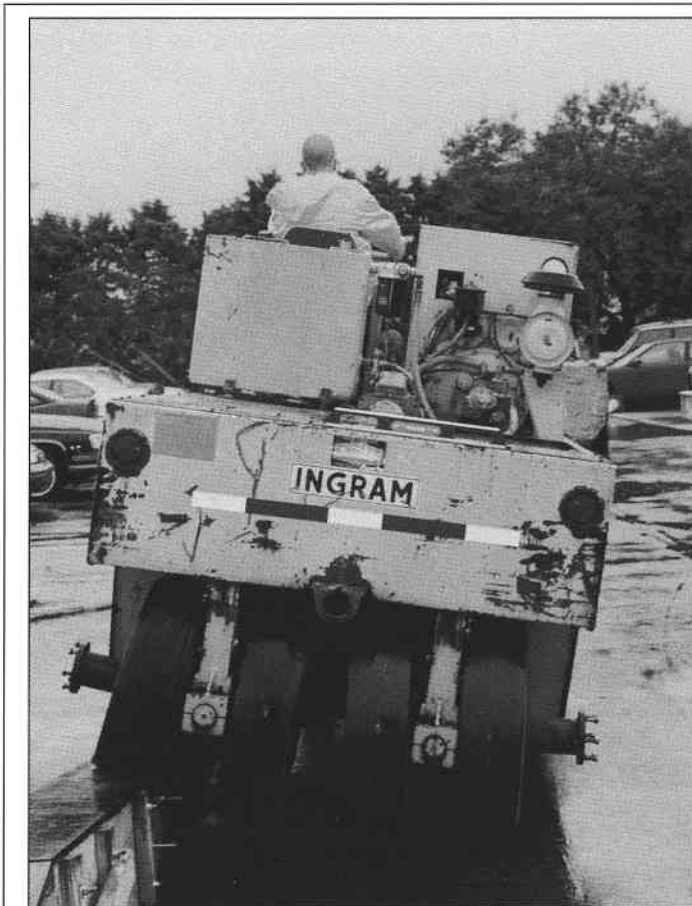
Figure 5a - Four Rear Wheels on 28.58 cm (11.25 in.) Ramp: 11.3°

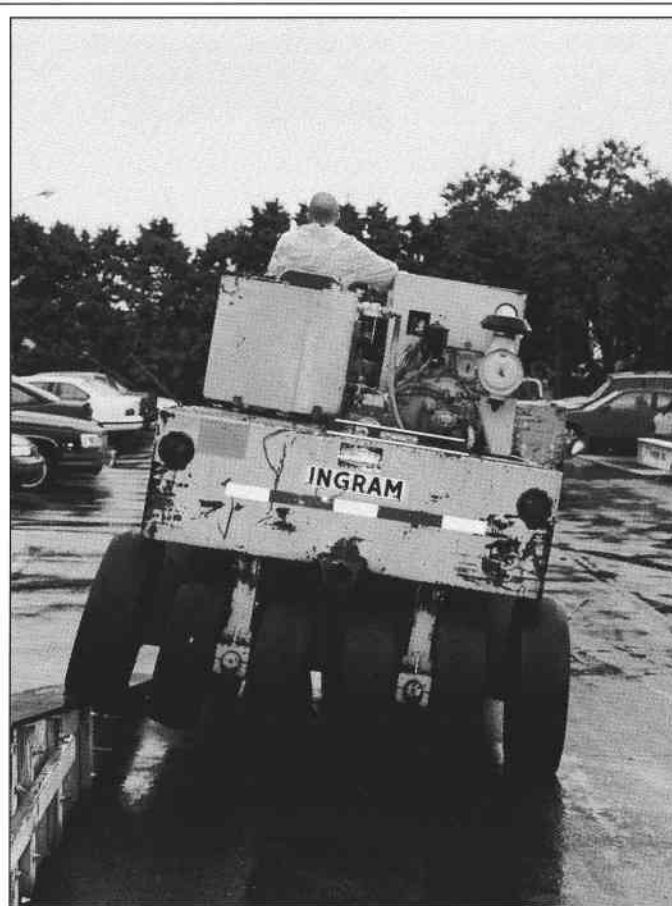
Figure 5b - Six Rear Wheels on 28.58 cm (11.25 in.) Ramp: 8.7°
