## THE RUNAWAY DIESEL - PART II A Side By Side Mechanical Analysis

By Christopher W. Ferrone\* and Charles Sinkovits\*\*

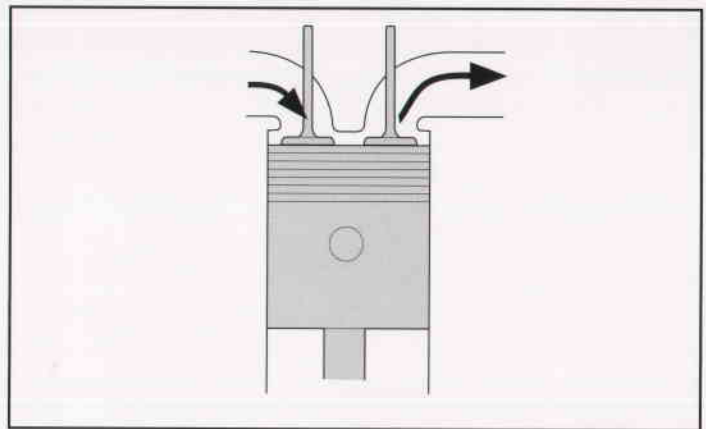
Figure 2 - Piston Valve Contact

In this condition the valve train components (tappets or cam followers) lose contact with the cam lobes because the valve springs are not strong enough to overcome the momentum of the various valve train components at the overspeed RPM. The onset of valve float usually prevents higher RPM operation due to loss of compression. Extended periods of valve float will damage the valve train and subsequently put the valves in contact with piston firing surfaces (Fig. 2). This will occur at engine speeds greater than the no-load maximum. Additionally, cylinder head components, valve spring retainers and locks can become damaged (Fig. 3). Once this happens, push rods can fall down through the engine block and into the oil pan. Along the way, the push rods may become bent, showing additional evidence of overspeed. Photo 6 shows valve contact with a piston on the South engine; photo 7 shows no contact with the piston on the North engine. Photograph 8 illustrates damaged valve components for the South engine; photo 9 shows no damage on the North engine.

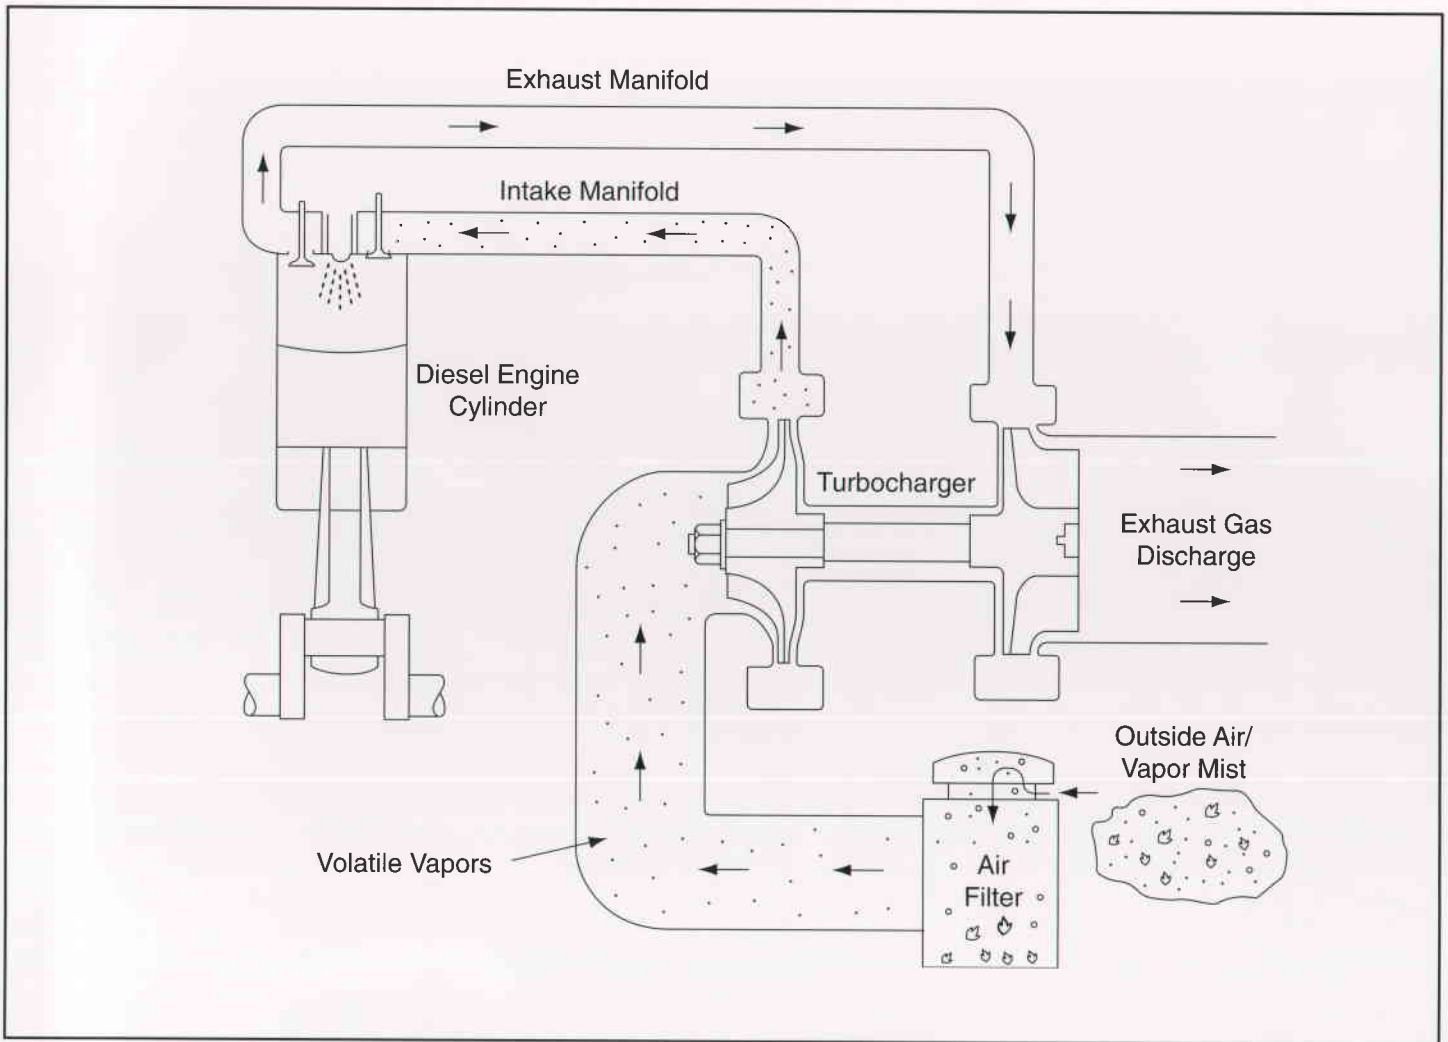
Figure 4 - Typical Air Intake System - 4 Cycle System

If the engine has ingested enough external combustibles and run away, the probability of fire dramatically increases. As the engine instability increases in magnitude, the likelihood of a "destructive backfire" increases. Specifically, the intake ducting and manifold fill with combustibles (Fig. 4) and due

to valve float, the combustion process is now open to the intake system, igniting the volatile mixture and creating a fire that moves backwards through the intake.

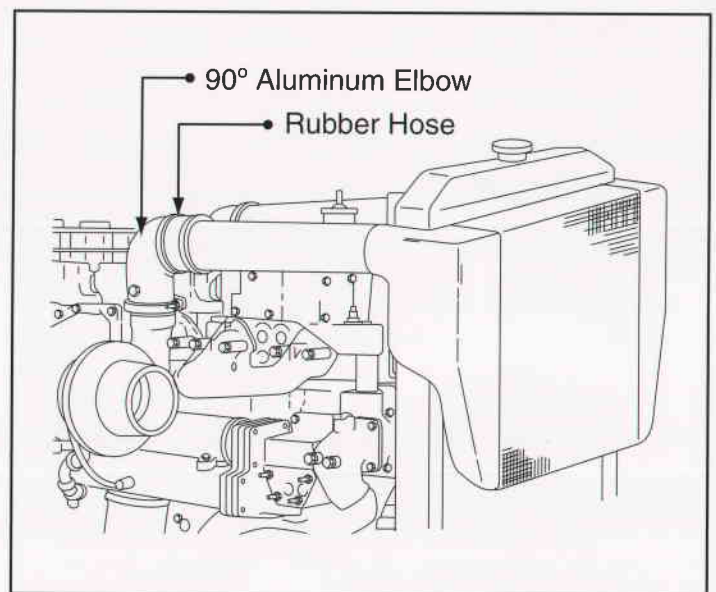
Figure 5 - Turbocharger to Aftercooler Connection

A destructive backfire is evidenced by a damaged turbocharger outlet elbow. Typically, the part is broken off of the turbocharger and "blown" clear of the main fire area (Photo 10). Damage to the 90° elbow and rubber hose (Fig. 5) is indicative of an explosion, not fire damage or heat. Photographs 11a and 11b show the South engine turbocharger with an explosion-induced broken elbow and rubber hose whereas photo 12 shows an intact, albeit melted elbow on the North engine turbocharger.

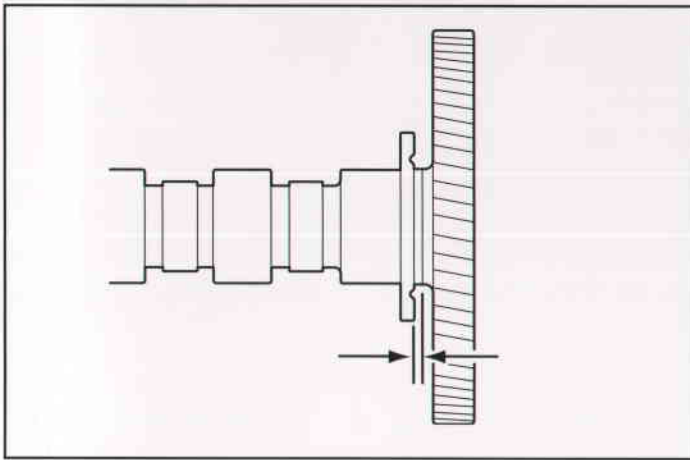
Figure 6 - Cam and Gear "Walk Off" Clearance

- Worn/broken valve collets
- Cam gear walk-off (Fig. 6)
- Larger valve lash than specified within the engine repair manual
- Valve collet wear markings below the prescribed collet groove (Fig. 7)
- Small cracks on the underside of the valve spring retainers (Fig. 8)
- Loose vibration damper/bolt hole fretting
- Loose flywheel/broken cap screws/bolt hole fretting
- Cam lobe stress marks
- Cam follower(s)/tappets - excessive wear
